Project Report

MEE7160

Effect of drilling process on hole quality, delamination of CFC

Author	Hector Figols Lopez [40158525]
Project supervisor	Dr. Elaheh Ghassemieh
Programme	MEng Aerospace Engineering
Date	15 May 2015

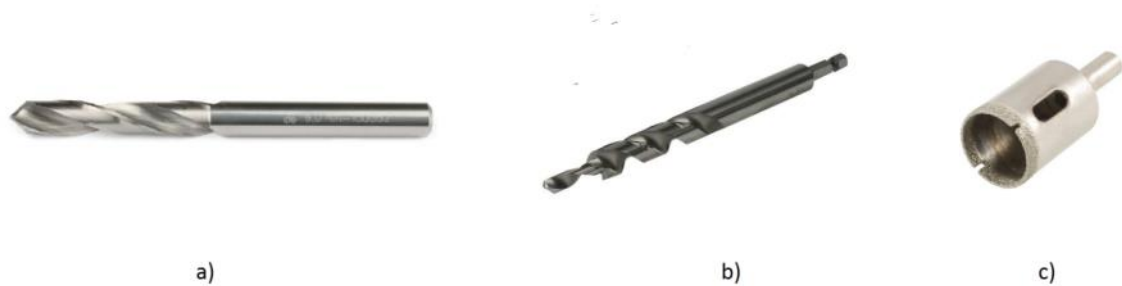
Figure 3. Different tool geometries: twist drill bit (a), step drill bit (b) and core drill bit (c)

As previously said, tool geometry is another main factor to be considered in the drilling process. There is a wide range of different drill forms, dimensions and tolerances. The best type of drill for a given application depends on several factors such as the work material and the hole characteristics. Among the many different types of drills, twist, step and core drills should be mentioned. For economic reasons among many others, twist drills (Figure 3a), so called because of their helical channels – flutes – for chip evacuation along their body, are the most common used and vary widely in their geometries [2]. On the other hand, step drills (Figure 3b) have been reported to perform great in composite laminate drilling, as their geometry allows smaller chisel edge effect and hence less thrust force, which is further reduced with a higher stage ratio [25]. Core drills (Figure 3c) also cut more efficiently than other conventional drills mainly because there is no stationary tool centre, which reduces axial force [7].

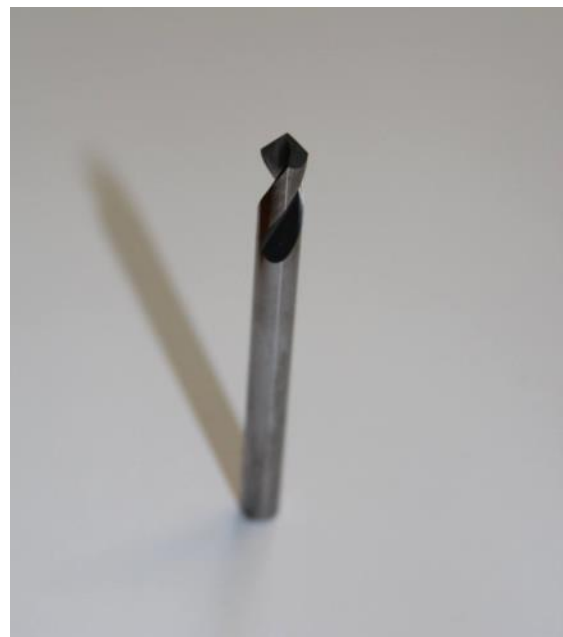
Figure 5. Dormer R123 6.0 solid carbide spotting drill uncoated

The selected drill bit was a Dormer R123 6.0 solid carbide spotting drill with 90 degree point, 17

mm flute length and a regular 29 degree rake angle. The catalogue specifications provided by Dormer Tools Ltd can be found in Appendix B. It is interesting to notice that this type of drill does not belong to any of the main types mentioned in the previous section. However, the company assured that it was the most appropriate model for the job due to its characteristics. The 90 degree point geometry gives a cleaner cut and better hole shape. Also, it reduces the amount of delamination around the hole edge when drilling layered materials.

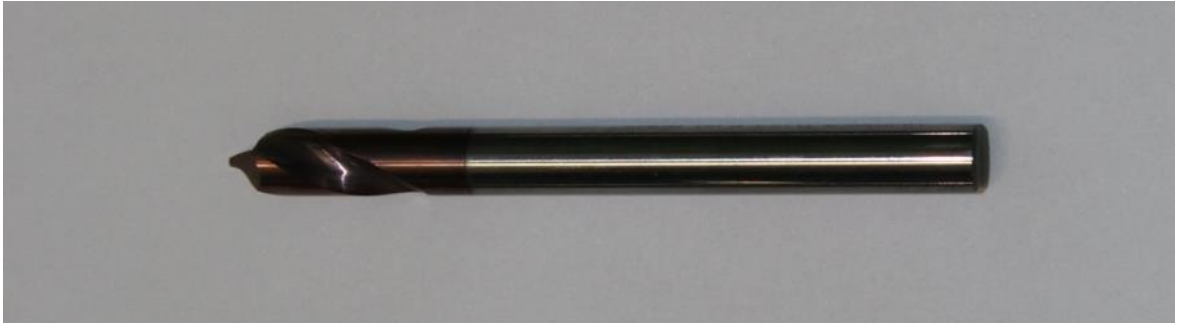
Figure 6. Dormer R123 6.0 solid carbide spotting drill coated

The hardcut coating that used some of the drills was a Titanium Silicon Nitride coating. No further information about the carbide or the coating could be given by the company due to its policy.

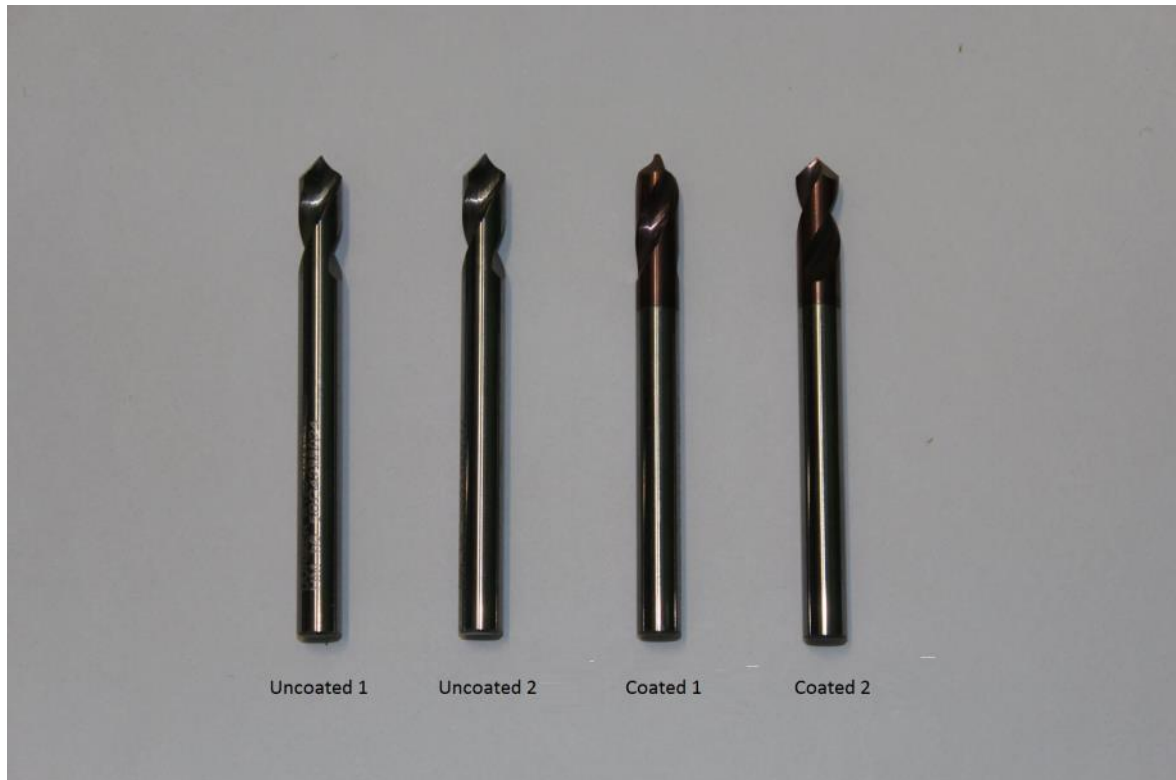
Figure 7. Whole set of drills used in the study: two uncoated and two coated

As it has been previously said, wear has a great impact on the thrust force and hence on delamination. To avoid this problem, two drill bits of each type were purchased. Thus, each single drill bit had to drill only 8 holes and wear could not develop enough to have influence on the results. The set of drills is shown in Figure 7. Uncoated 1 and Coated 1 would drill tests 1 to 8 and Uncoated 2 and Coated 2 tests 9 to 16.
